December 2009

## SubSea Solutions Newsletter

## What happens when they don't "Azimuth"?

## Time for a Thruster Overhaul

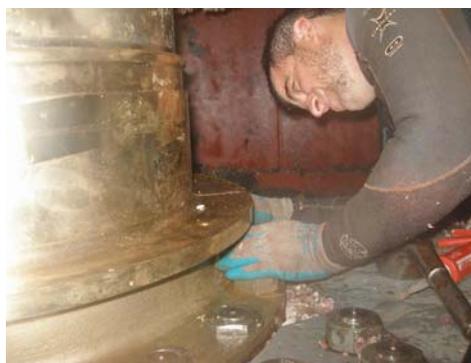
**Retractable Azimuthing Thrusters repaired in the retraction column**

The completely seized Port side azimuthing thruster was retracted as far as possible up into the retraction column. Once retracted two-thirds of the way into the vessel, the retraction column was "blown-down" to create a dry environment around the affected bearing based on the engineered plan developed by the **Subsea Solutions Alliance**. The Diver / Technicians then

used specialized equipment and techniques to quickly remove the bearing carrier, race and liner. Additionally, the chockfast used to set the bearing into its proper position was blasted away with a specialized hydro-blaster specifically adapted for this application. Once the affected area of the thruster was completely disassembled and cleaned, a new bearing and liner was installed on the unit. The bearing was then properly aligned and chockfast was poured to permanently secure the bearing in place. Under the watchful eyes of the Owner's representative and the OEM service engineer the repair was completed.

Simultaneously, another crew of **Subsea Solution Alliance** personnel initiated the same repair on the starboard azimuthing thruster. In this case, as the unit was not yet seized, the unit could be retracted completely into the retraction column for repair. Just like the port side thruster, the entire repair was performed under the watchful eyes of the Owner's representative and the OEM service engineer. In total, the **Subsea Solutions Alliance** had 25 diver / technicians on site working around the clock in 2 shifts to complete the repair of these two thrusters!

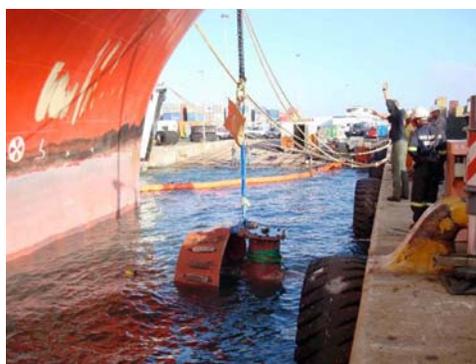
**Retractable thruster lower unit brought to surface for overhaul**

Even though the Retractable thruster lower unit is NOT designed for underwater demounting, the **Subsea Solutions Alliance** together with the engineering department within the OEM developed a safe and efficient procedure for the lower unit extraction. The extraction procedure included the securing of the Steering tube which is a twin tube mechanism that slides up and down within the retractable unit based on it's position. The Engineering team within the **Subsea Solutions Alliance** incorporated techniques to develop the specialty tooling required to perform this pioneering service within the dry environment created in the retraction column within the vessel. Combining this tooling together with **Subsea Solutions Alliance's** experience handling large and heavy equipment underwater, the 14 ton thruster lower unit was safely extracted and brought to the surface for overhaul.

Upon completion of the lower unit overhaul by the Original Equipment Manufacturer, the unit was safely reinstalled without any incident.

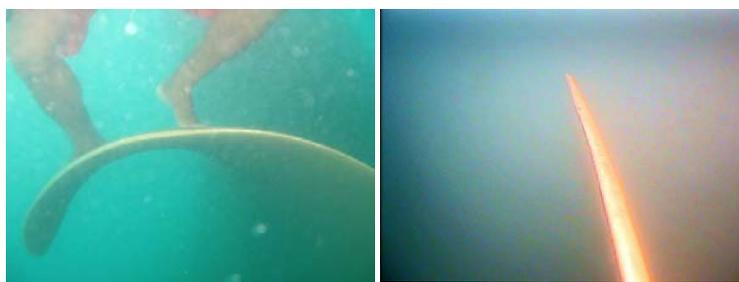
The **Subsea Solutions Alliance** in The Netherlands was contacted by a European client reporting severe propeller damage in the vicinity of Australia. Based on the initial diver report and pictures reviewed, the propeller specialists within the **Subsea Solutions Alliance** confirmed that a repair was available utilizing the underwater propeller straightening press combined with a hydrodynamic engineering solution. The severe damage to the propeller caused considerable engine overload and the vessel speed was considerably affected.

The **Subsea Solutions Alliance** dispatched personnel and equipment from it's member companies in The Netherlands and Vancouver Canada for the repair. Under the watchful eye of the attending Class surveyor, the repair commenced combining a cold static load straightening process together with hydrodynamic balancing of the propeller. Utilizing proprietary laser measurement techniques together with experienced propeller diver / technicians, the engineering department of the Subsea Solutions Alliance developed a repair solution that was predicted to provide an operational improvement in propeller performance. Upon completion of the repair, the vessel departed without any sea trial.
