SubSea Solutions Newsletter

Rapid Cost-Effective Worldwide Underwater Repair Solutions

In This Issue- SSA Highlights

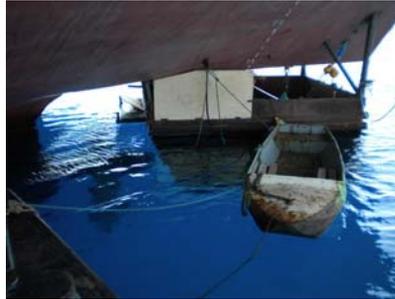
A fully laden bulk carrier called the **Subsea Solutions Alliance** to perform the removal and repair of a 50 ton rudder after a grounding occurred in South America. Prior to the arrival of the vessel, the **Subsea Solutions Alliance's** engineering department developed and fabricated a cofferdam to displace 130 cubic meters of water. Upon the arrival of the vessel to the Caribbean a full inspection was performed by the **Subsea Solutions Alliance** team. The 50 ton rudder was

removed with the damaged rudder stock still installed. A purpose built cofferdam was installed and the vessel was prepared for an "in water repair". The damage incurred from the grounding was more extensive than previously considered.

Over the past months a repair to both the rudder and severely damaged rudder horn has been taking place. A full class approved permanent repair was requested by the underwriters of the vessel and subsequently is being performed by the **Subsea Solutions Alliance**. The repair includes the relocation of the rudder horn and line boring for new bushings, structural repairs with class approved insert plates in the stern section of the vessel, rudder blade repairs internally and externally, new foundations for the steering gear, the Steering gear overhauled by Rolls Royce, the Original Equipment Manufacturer and other small hull insert repairs along the vessels bottom. The vessel is expected to sail in June 2009.

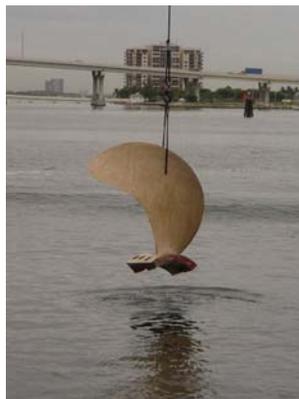
After a grounding in Caribbean, a cruise vessel sustained propeller damage. The propeller specialists from the **Subsea Solutions Alliance** was called in to assess the damage and perform a temporary repair to alleviate the heavy vibration issue on board. As the damage was significant in order to relieve the propeller of the damaged sections a large

portion of the propeller's blades were removed. This caused a loss of speed which affected the vessels itinerary. With new blades available, the fixed pitch built up propeller blades mounted on the podded propulsion unit were exchanged in opposing pairs. This work was performed without any impact to the vessels schedule by the **Subsea Solutions Alliance** while the vessel cruised the East Coast of North America.

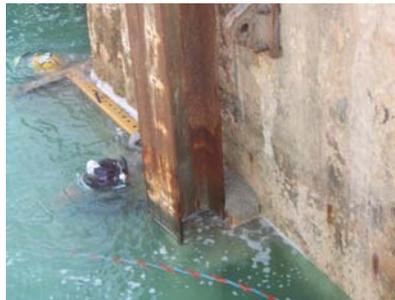
After years of reliable service, the cruise terminal in Freeport Bahamas required maintenance and repair due to heavy erosion and the formation of caverns underneath the pier. As part of an overall repair of the facility, the **Subsea Solutions Alliance** was hired to repair 800 feet (244 meters) of the sea wall to a depth of 50 feet (15.25 meters). The scope of work included drilling into the limestone bed rock and setting re-bar into the limestone bed rock at 1 foot centers, filling the holes with Epoxy and building / installing forms to pump the proper grade concrete into the area to restore the pier's sea wall. Over a few month period the crew of 6 diver / technicians finished the job on time without a hitch.
